GMB

T E C H N I C A L R E P O R T

COUNTERFEIT PRODUCT

Universal Joint

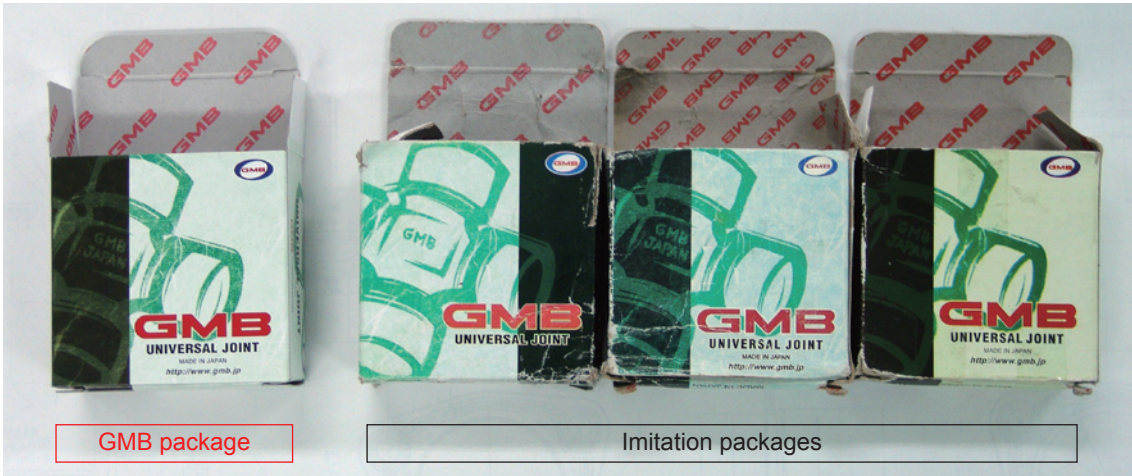
Note the comparison between GMB package and imitation packages which have duplicated the trademark and pattern illegally and used without permission

- There are differences noticeable in the trademark imitation package such as color, inside print or existence or nonexistence of "JAPAN" letter.

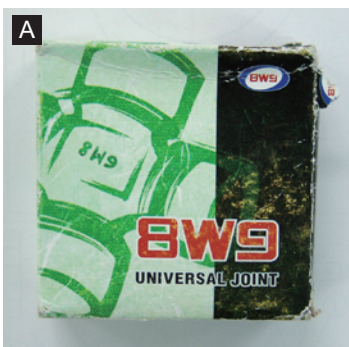
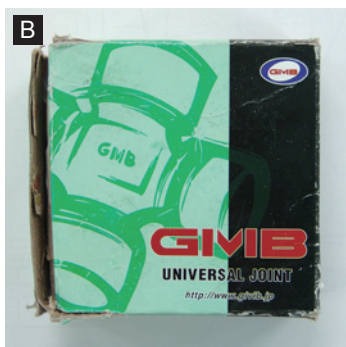
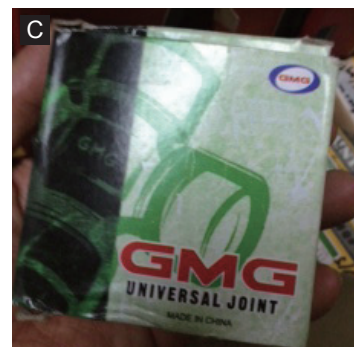
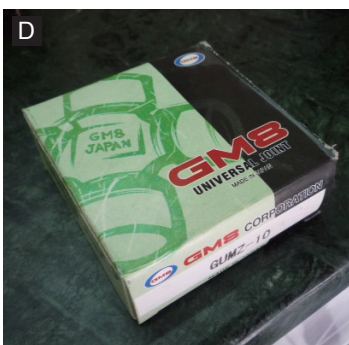
Note the examples of the trademark similar package which have changed the character string of the trademark of GMB and transformed **A B C D**

- A letter in the logo mark and the letter of the pattern center change into equivalence, too.
- In example **C** the country of origin was written as MADE IN CHINA.
- In example **B** there is a WEB site address printed that does not exist.

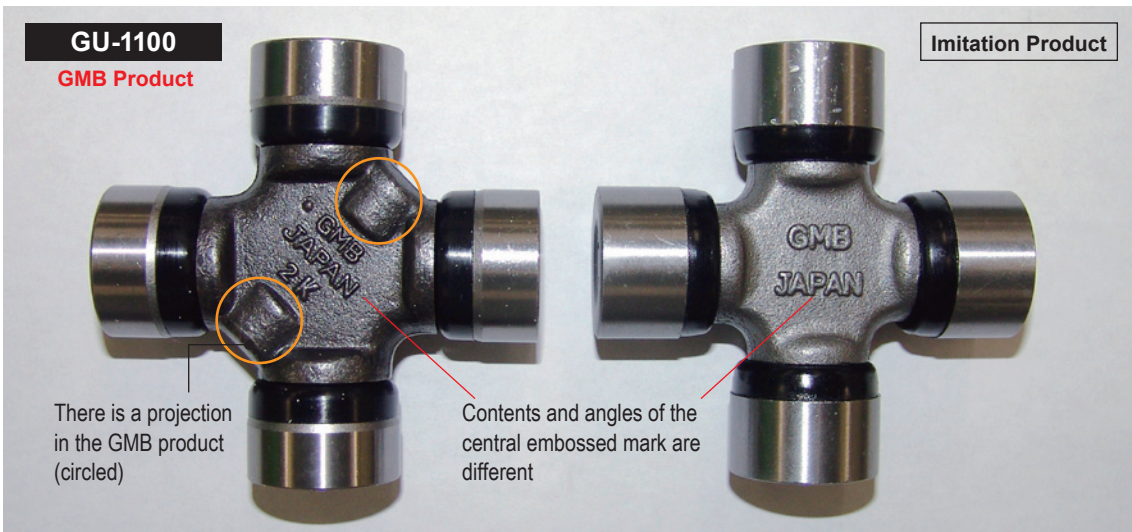
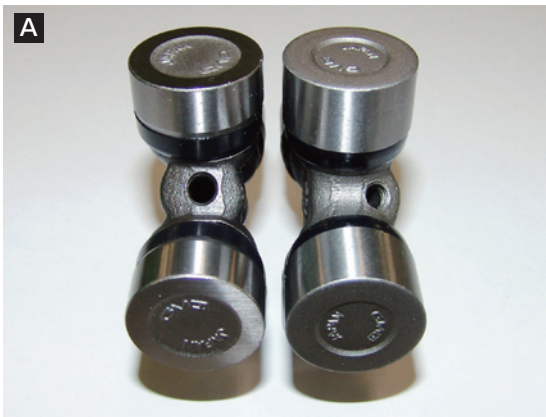
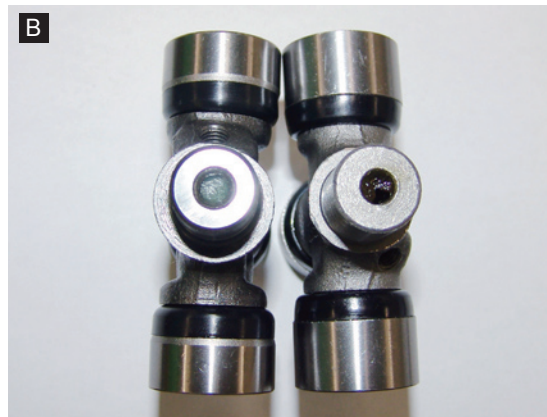
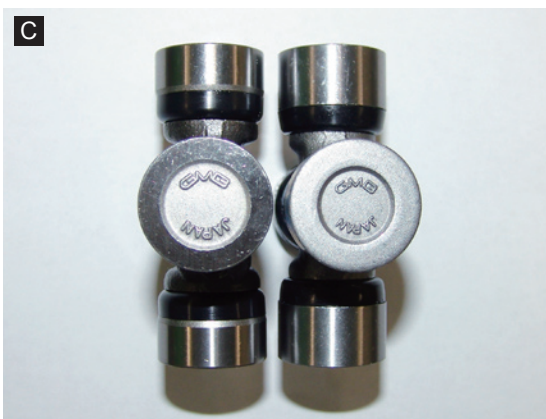
Appearance comparison from the other angle

As for the imitation product, not only the package but also the product itself is similar and the shape is imitated precisely. This time, we compare the appearance shape with the imitation product thought to be the article equal to our product **GU-1100**.

- The shape and the external form dimensions are very similar in appearance.
- An embossed marking is processed into bearing cases like the GMB product, but form and the size of the letters are delicately different. **C**

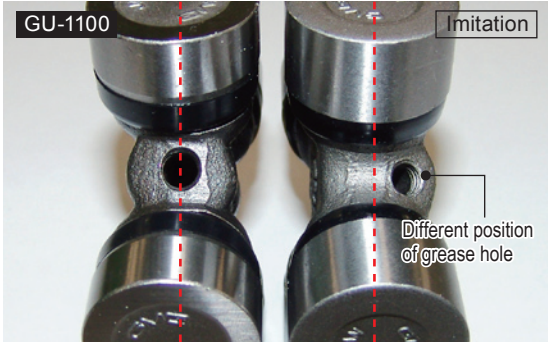
Grease Hole

- Grease hole of GMB product is placed in the center of the side body, but the imitation product has slipped from the centerline.

Various differences are seen in GMB and imitation product in the product treatment processing. Essential processing is not considered important to the imitation product. The precision is low and quality is uneven. Therefore, imitation products have problems such as loose fitting bearings (easy to fall out) or rotational roughness of bearings. Because of low quality processing imitation product are likely to seize under use resulting in the defective units shown in pictures.

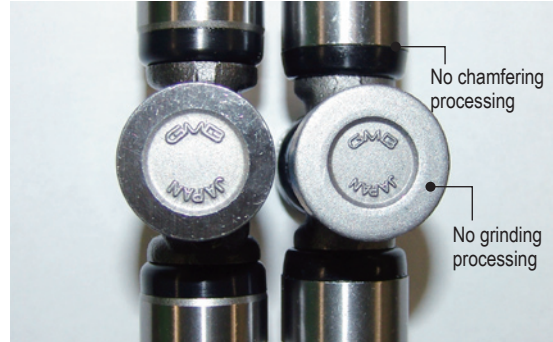
Bearing Case

- The imitation product has no chamfering and grinding processing of the bearings.

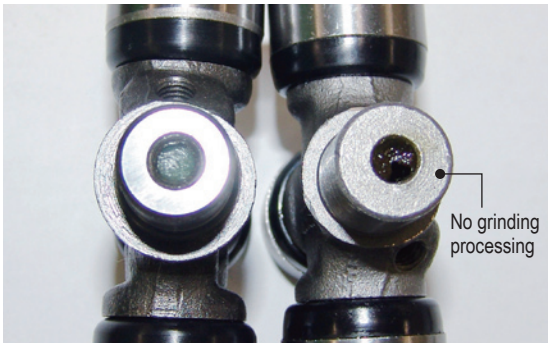
Cross

- Imitation product does not use grinding process on the trunnion end face.

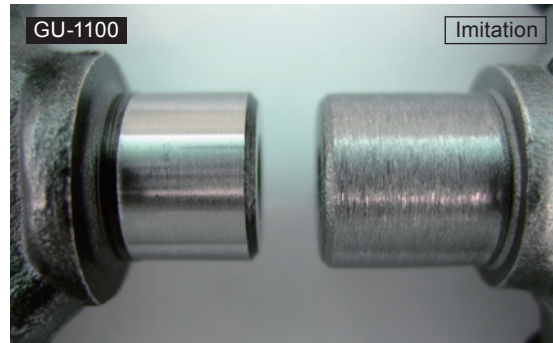
Trunnion

- The finish of the trunnion on the imitation product is extremely rough so the rotation of the bearing is not smooth.

⚠ Where the correct processing on the imitation product has not been made, there is the risk of overheating the bearings leading to collapse.

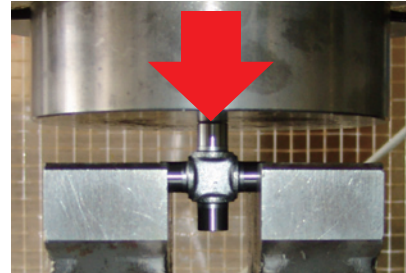
[Test method]

1. Fix the cross of the universal joint as per right picture.
2. Add load from the top and measure maximum load until the cross is destroyed.

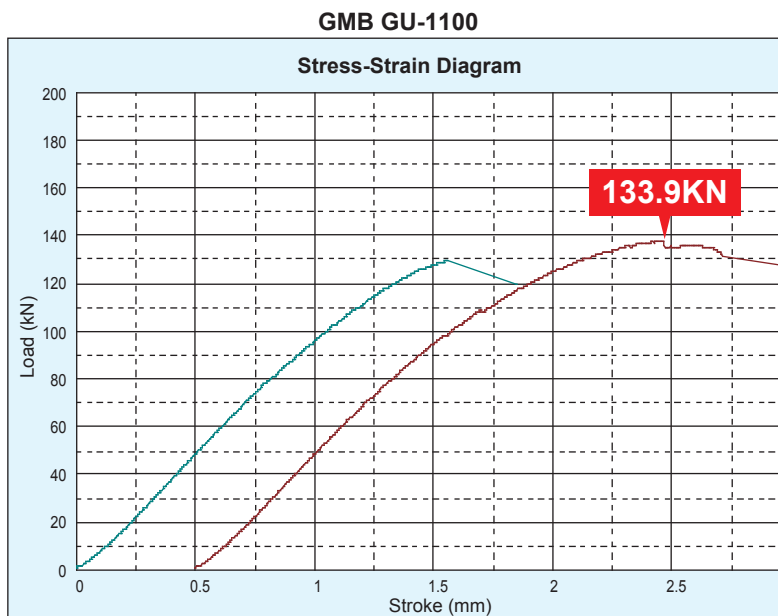
The left-hand figure is data expressing the result of the breaking strength examination of GMB GU-1100.

You can see that load of 133.9kN is necessary before destruction happens in the case of GMB GU-1100.

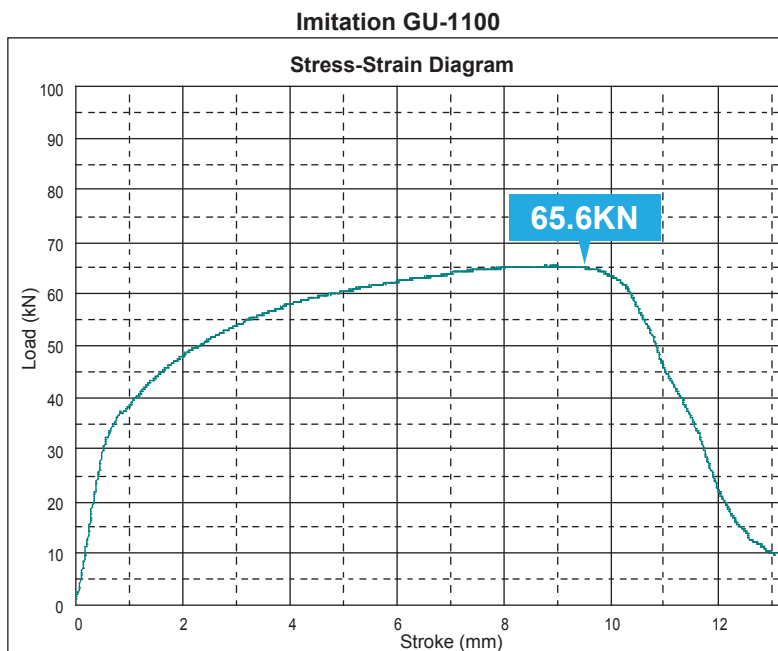
On the other hand, the breaking strength of the imitation GU-1100 was remarkably low and has been easily destroyed by load of 65.6kN less than half of GMB GU-1100.

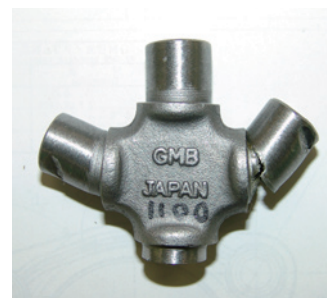
Picture of Imitation GU-1100, which was transformed and destroyed by only 65.6kN.

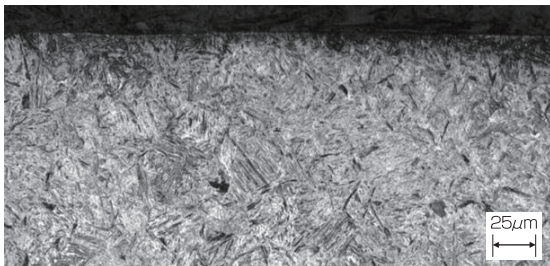
Metallurgical structure of heat-treated GMB GU-1100

Generally, in the trunnion of the cross, a heat-treatment process is applied for the purpose of abrasion resistance, strength and life improvement. The ideal design is to have a hard surface area with the core becoming softer at greater depth to give hard wearing surface but with a tough, flexible core. You can see that heat-treatment is applied with the section photograph of GMB GU-1100 from the following comparison section pictures between GMB and imitation product. The darker section at outside edge of the circle is called carburizing and works from the surface over the inside letting carbon soak by heat-treatment and caseharden intentionally. On the other hand, the imitation product does not have the heat-treated trace, and metallurgical structure is constant from the surface to the inside.

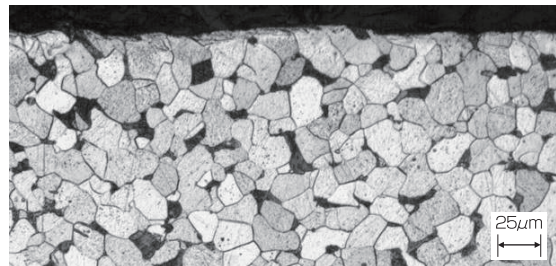
Imitation Product

Metallurgical structure of the imitation product that is not heat-treated

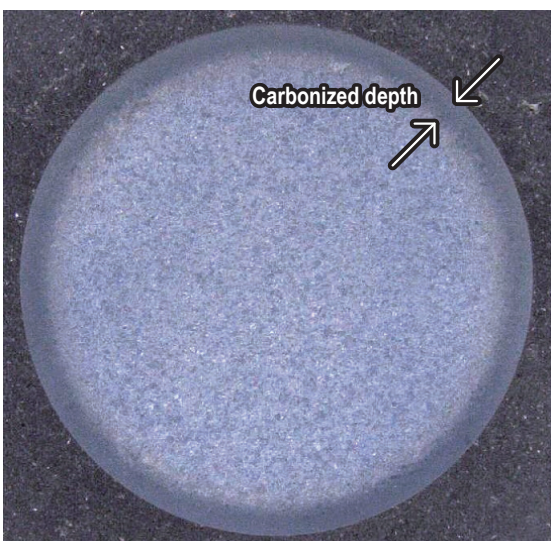
GMB GU-1100 is properly carburized from surface and casehardened by heat-treatment.

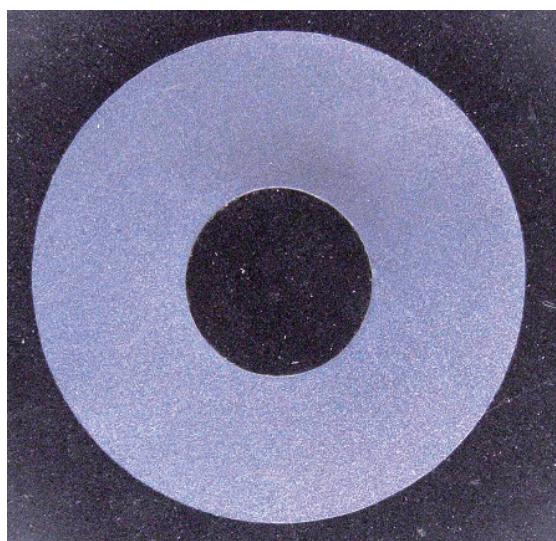
Imitation Product

The imitation product is not heat-treated and casehardened because metallurgical structure is homogeneous.

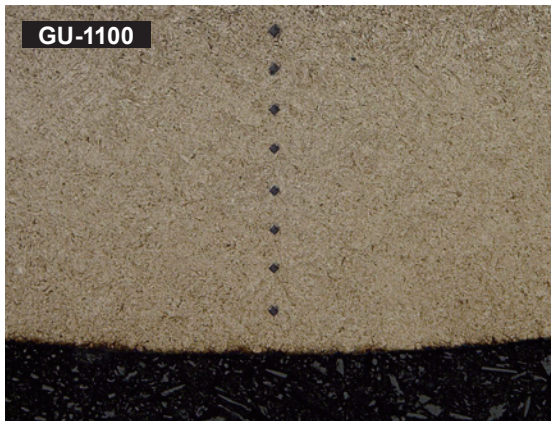
Enlarge carburizing part to 200 times

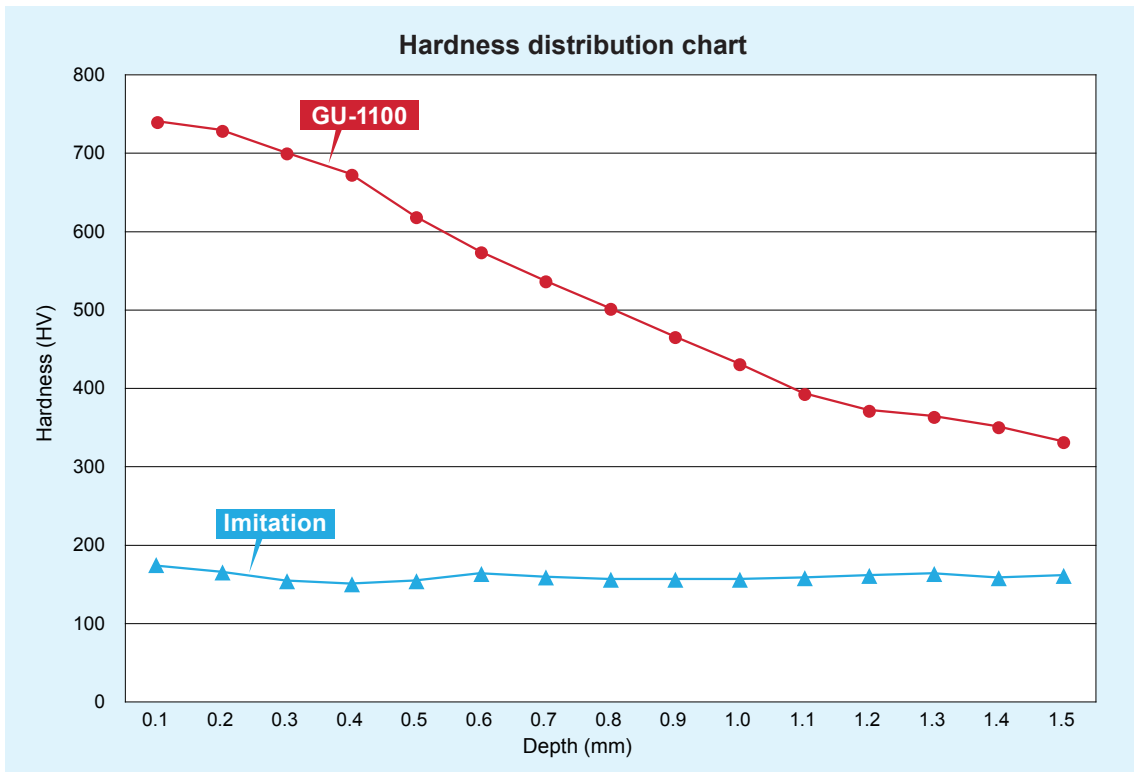
Generally, metal is very fragile and easy to break under high power loading when there is a high hardness homogeneity from the surface to the inside. Conversely, metal transforms easily under high power loads in the case of low hardness homogeneity. The following graph is the data which measured the hardness of the metallurgical structure of the cross trunnion.

In genuine GMB GU-1100, we can see that the hardness is high around the surface and lower to the inside.

Heat-treatment was not applied to the imitation product that we investigated this time and has easily transformed at a load less than half of GMB GU-1100 in the breaking strength examination due to the extremely low hardness as confirmed from the hardness distribution chart.

We can say that the abrasion resistance property is virtually nil with such low hardness.

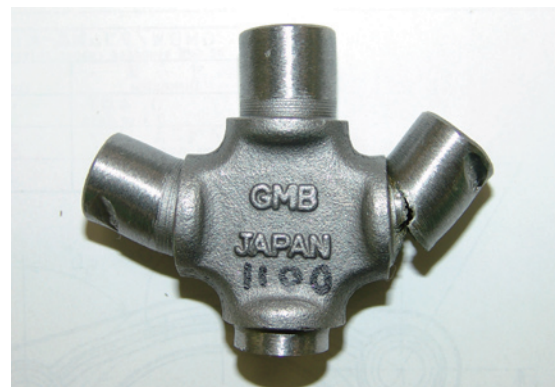
Imitation GU-1100, which was transformed and destroyed.
